# Clean Air Act Partial Compliance Evaluation Inspection Report

## *Valley Landfills Inc. Coffin Butte Landfill*

2917 Coffin Butte Rd  
Corvallis, Oregon

Inspection Date: June 21, 2024

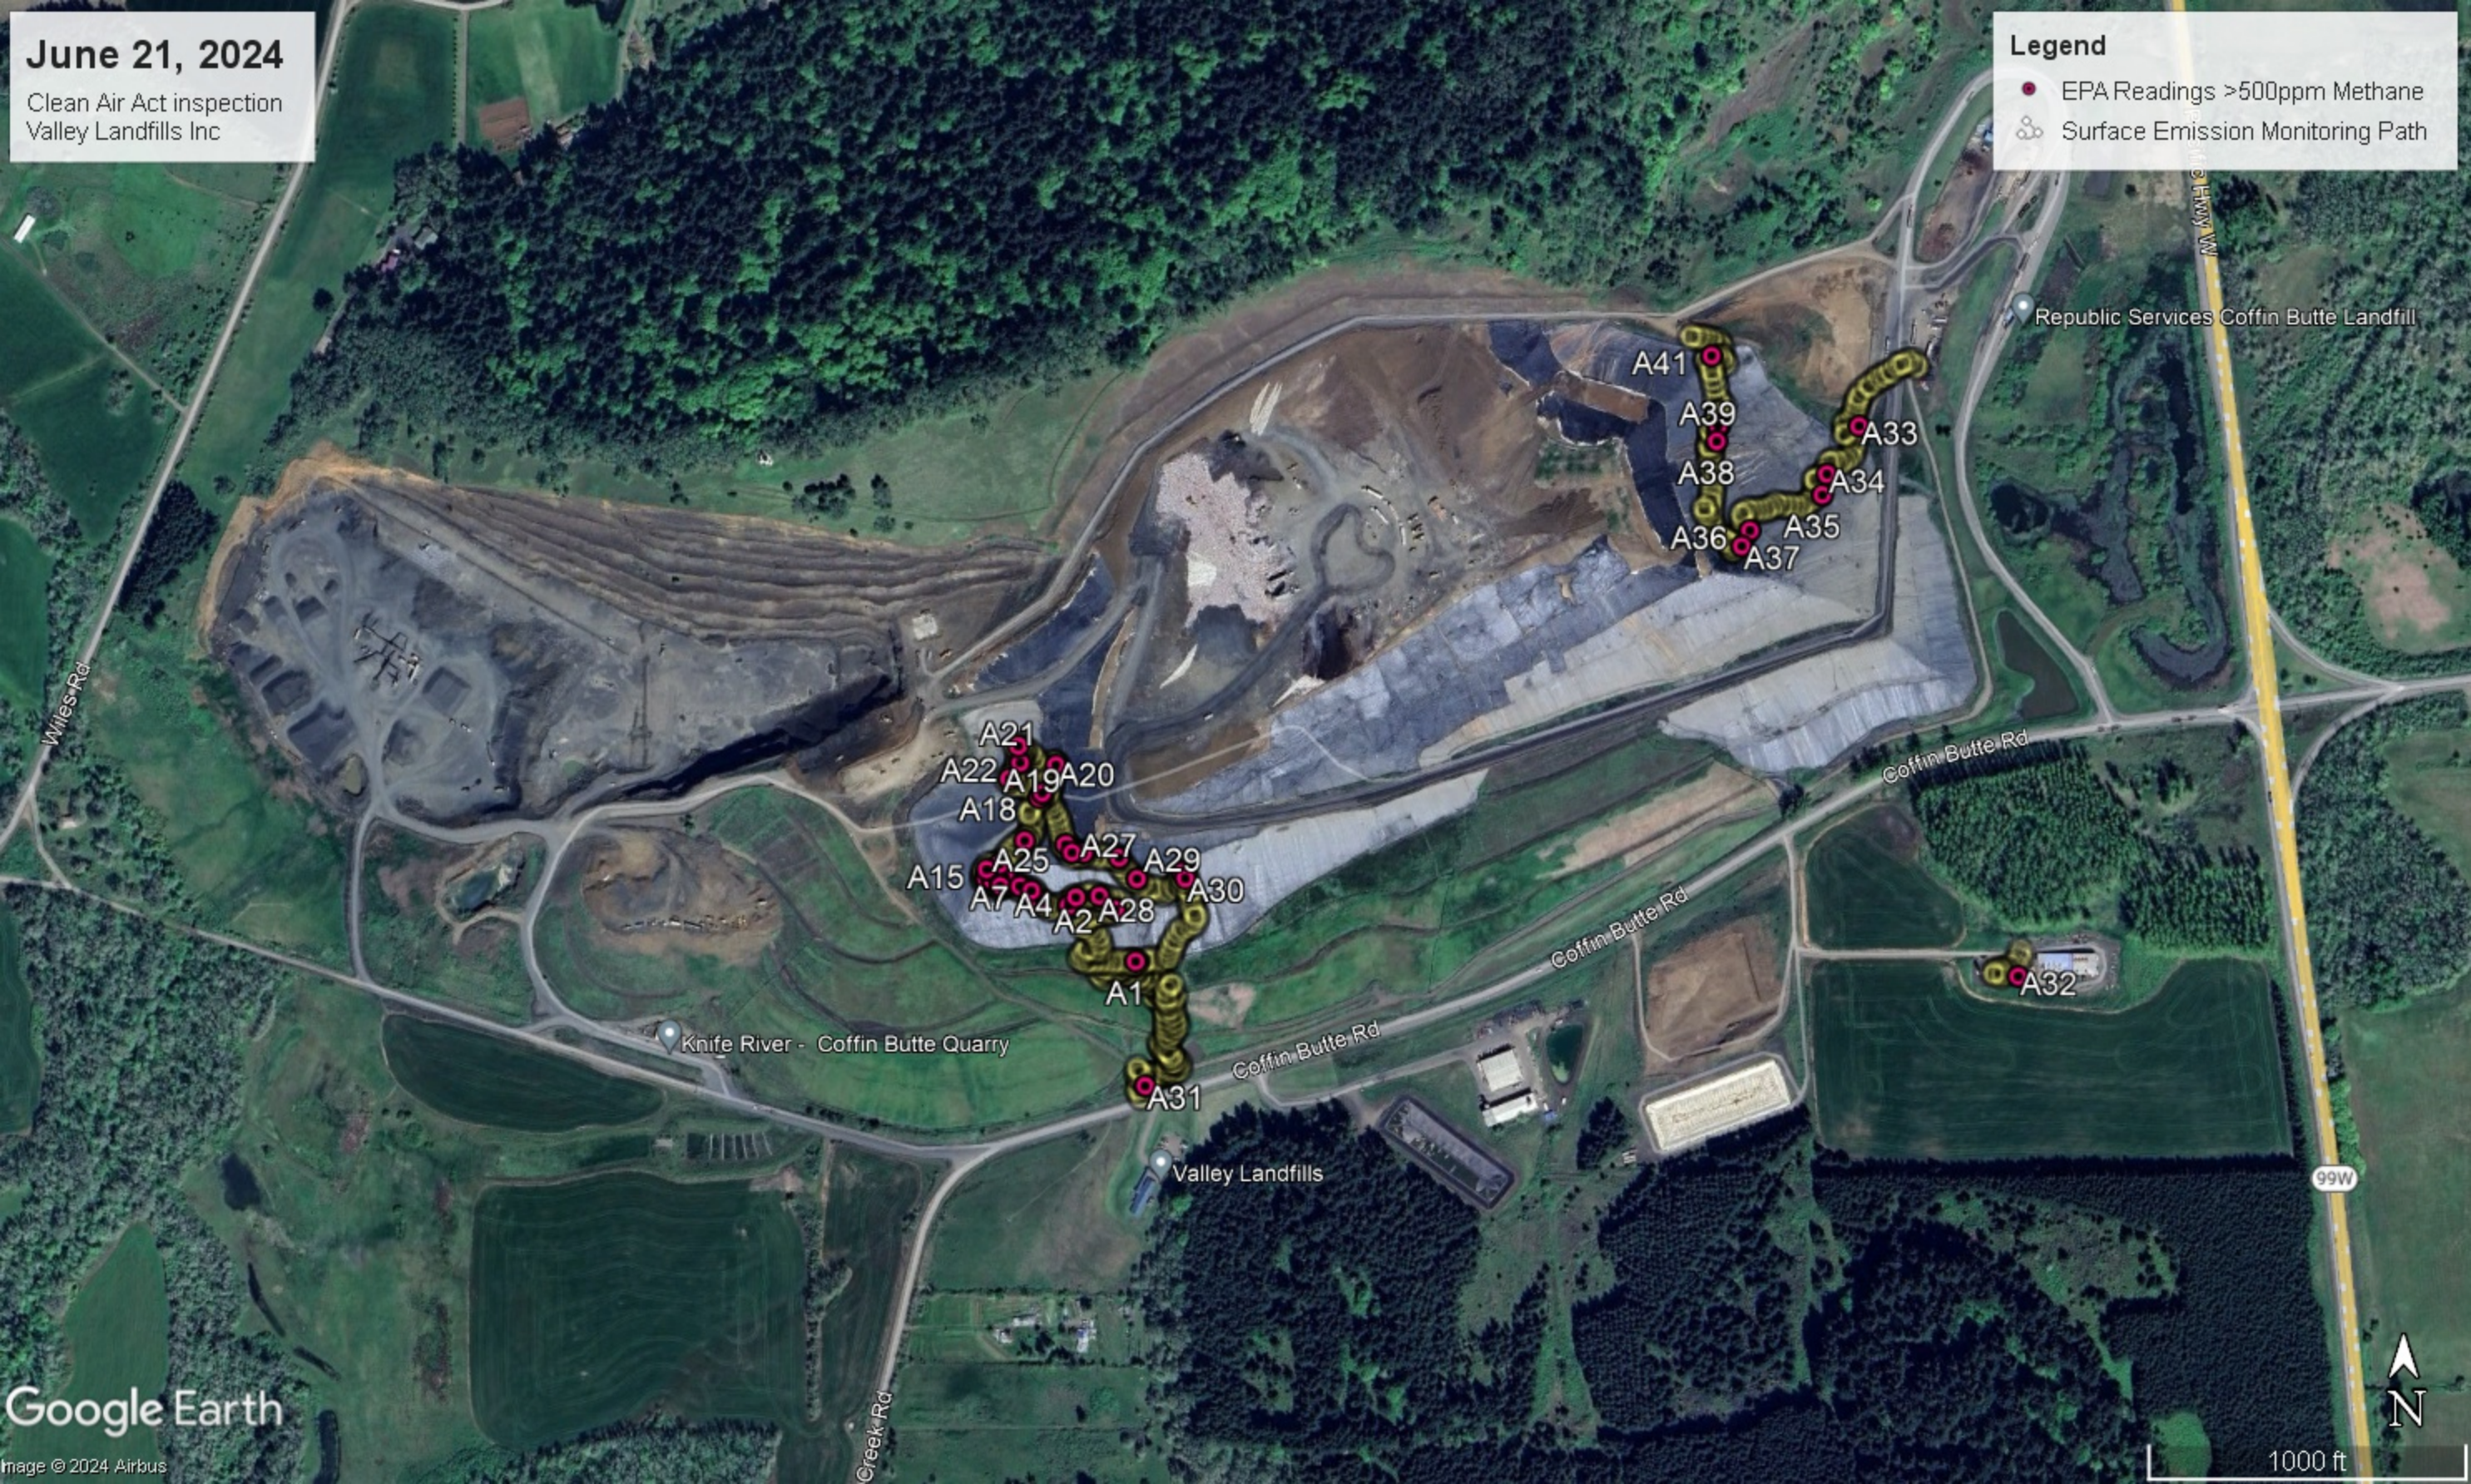
**Attachment 2: EPA Surface Emission Monitoring Map**

The table of surface emissions exceedances and digital image log is included as Attachment 1 to this report. A map of the Surface Emissions Monitoring (SEM) path walked by Inspector Rapp with the EPA IRwin is included in Attachment 2.

1. EPA monitored only a portion of the landfill surface and found numerous methane emissions at 500 ppm and higher, including at holes in the cover material. We identified many of the approximately 40 exceedances at locations where the cover material was damaged. Inspectors had noticed some plants growing out of the cover material near the areas where we monitored for emissions.
2. EPA monitored a flange at the flare station had methane emissions over 500ppm. The facility indicated that they were repairing this flange while we were in the opening conference.
3. One of the wellheads EPA monitored to was open to the atmosphere and the IRwin measured emissions over 500ppm.
